# FRENCH QUARTER STREETLIGHT ASSESSMENT 2022 WALKING SURVEY

FIELD DATA COLLECTED BETWEEN  
FEBRUARY and SEPTEMBER 2022

Compiled by:  
Dave Jorgensen & Volunteers  
FQMD Livability Committee  
(904) 631-6880 (mobile)

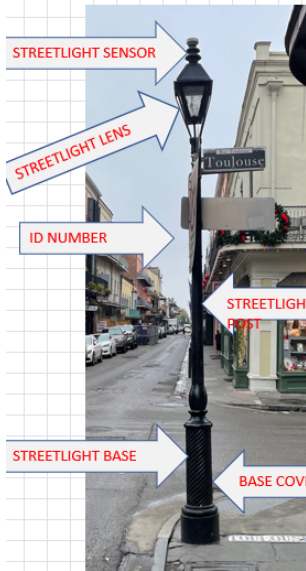
## STREET LIGHT POST SURVEY

SENSOR MUST BE VERTICAL AND CONNECTED TO LAMP

LENSES SHOULD BE PRESENT IN PROPER FRAME AND CLEAN

LIGHT POST SHOULD BE PAINTED VERTICAL AND WITH OUT BENDS OR RUST

ASSET ID NUMBER IS LOCATED ABOUT 8' FROM THE SW NUMBERED VERTICALLY. THIS NUMBER IS NOT ALWAYS PRESENT BUT IS ESSENTIAL TO RECORD IN SYSTEMATIC ORDER TO IDENTIFY LIGHTPOSTS IN SEQUENCE.

BASE SHOULD BE PAINTED, VERTICAL AND WITHOUT RUST

BASE COVER MUST BE IN PLACE EITHER ORIGINAL EQUIPMENT PREFERRED OR SUBSTITUTED WITH BANDING AND PLATE. IT IS A CODE VIOLATION TO ALLOW ACCESS TO THE WIRING AT THE BASE OF LIGHT POSTS. **HAZARD!**
