# FRENCH QUARTER STREETLIGHT ASSESSMENT 2022 WALKING SURVEY

FIELD DATA COLLECTED BETWEEN  
FEBRUARY and SEPTEMBER 2022

Compiled by:  
Dave Jorgensen & Volunteers  
FQMD Livability Committee  
(904) 631-6880 (mobile)

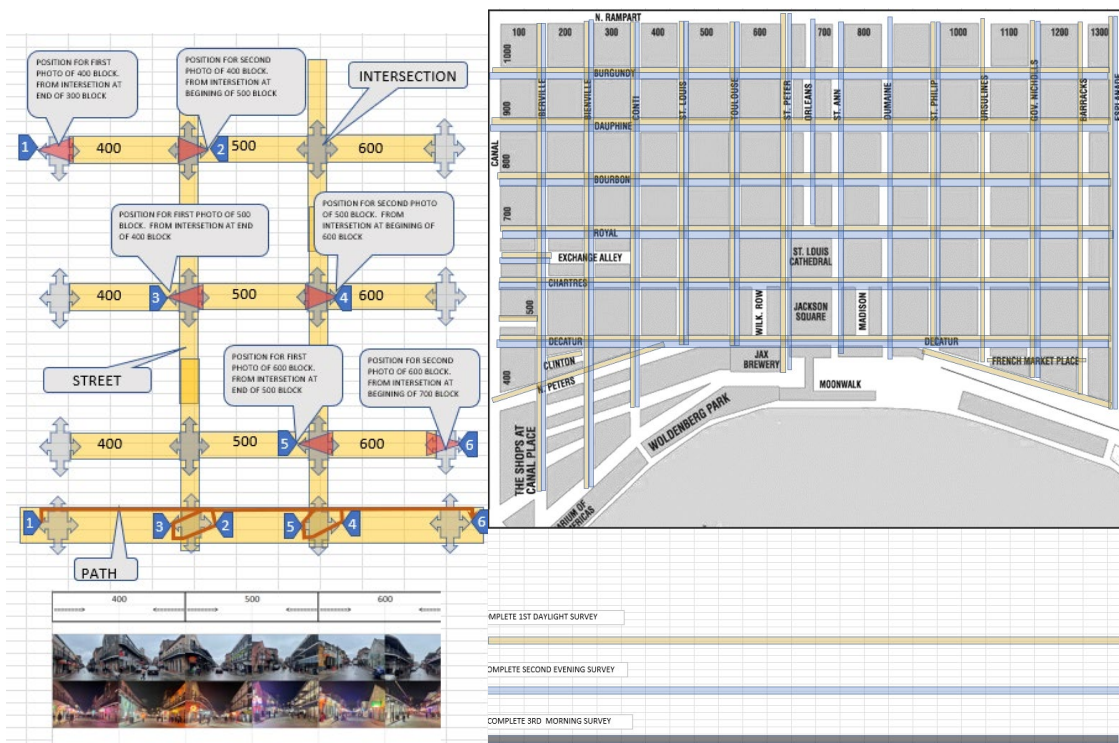
A quick review of equipment outages at the 200 block of Dauphin Street and the images provided during the street view survey illustrate this point.

DAUPHINE STREET		SURVEY JORGENSEN 02032022		
LIGHT ID (1)	CLOSEST ADDRESS	SENSOR	LIGHT & LENS	FUNCTION
AV 157	438	OK	RESET LENS NEED CLEAN	
AV 158	431	OK	RESET LENS NEED CLEAN	
AV 159	430	OK	NEED CLEAN	
AV 160	415	OK	OK	
AV 161	400	OK	NEED CLEAN	5G
AV 163	340 (846 CONTI)	OK	OK	DUPUY PLATE
AV 164	335	OK	OK	
AV 165	320	OK	NEED CLEAN	
AV1 166	323	OK	OK	
AV 167	306	OK	NEED CLEAN	
	241	MISSING	DAMAGED REPAIR	NO
AV 169	240	MISSING	MISSING	NO
AV 170	234	MISSING	DAMAGED REPAIR	NO
AV 171	240	OK	OK	
AV 172	215	OK	OK	
AV 173	200	OK	DAMAGED REPAIR	
AV 174	201	OK	OK	
AV 175	140	OK	OK	
AV 176	137	BROKE	RESET LENS NEED CLEAN	
AV 178	135	OK	NEED CLEAN	
AV 179	100	OK	OK

With adequate maintenance replacing, repairing, or cleaning these streetlights additional visible light would deter criminals and provide far greater confidence to residents and guests of the French Quarter.
